Chapter 4 – Unit Improvements - Whole House

4.1 Unit Improvements Overview

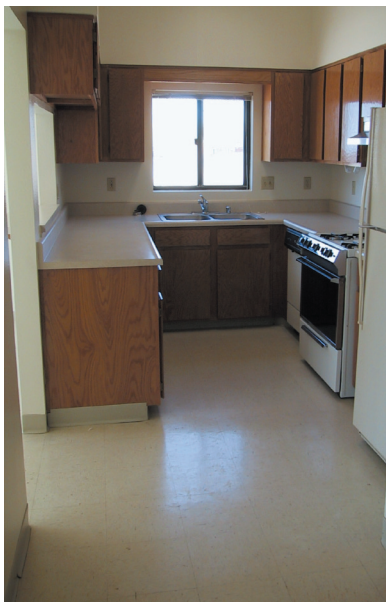
Kitchen

- Cabinets: wood; fair condition; interior finish worn.
- Counter Tops: laminated; good condition.
- Sink: stainless sink, double; fair condition; worn finish.
- Sink Fixtures: metal; fair condition; worn finish.
- Refrigerator: standard; good condition.
- Range/Oven: gas; fair condition; model dated.
- Vent Hood: exhaust fan; good condition.
- Dishwasher: standard; good condition.
- Garbage Disposal: standard; fair condition.
- Flooring: vinyl composition tile; fair condition; corroded.
- Walls: gypsum wall board; good condition.
- Wall Finish: painted; good condition.
- Ceilings: gypsum wall board; good condition.
- Ceiling Finish: painted; good condition.
- Interior Hardware: none; not required.

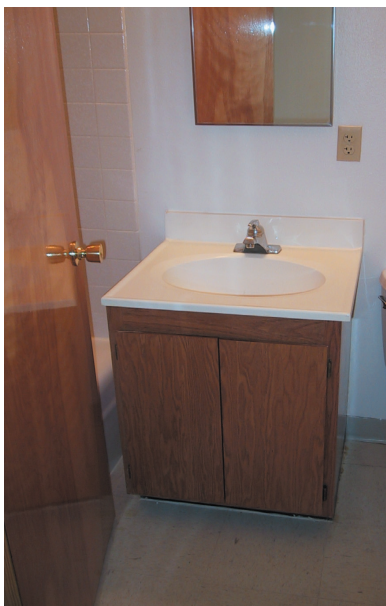
Bathroom 1

- Cabinets: wood; fair condition; worn interior; door finish slightly worn.
- Counters: cultured marble; good condition.
- Sink: cultured marble; good condition.
- Fixture Hardware: metal; fair condition; worn finish.
- Toilet: porcelain; good condition.
- Tub/Shower: combination; good condition; ceramic tile surround.
- Flooring: vinyl composition tile; fair condition; loose at toilet.
- Walls: gypsum wall board; good condition.
- Wall Finish: painted; good condition.
- Ceilings: gypsum wall board; good condition.
- Ceiling Finish: painted; good condition.

- Ventilation: exhaust fan; fair condition; older unit.
- Interior Hardware: metal; good condition.

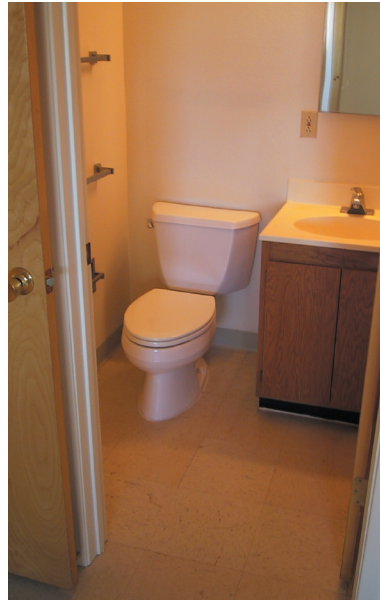
Bathroom 2

- Cabinets: wood; fair condition; door finish slightly worn.
- Counters: cultured marble; good condition.
- Sink: cultured marble; good condition.
- Fixture Hardware: metal; fair condition; worn finish.
- Toilet: porcelain; fair condition; older fixture.
- Tub/Shower: shower; fair condition; ceramic tile surround with glass shower doors; worn grout at drain base.
- Flooring: vinyl composition tile; fair condition; minor water damage.
- Walls: gypsum wall board; good condition.
- Wall Finish: painted; good condition.
- Ceilings: gypsum wall board; good condition.
- Ceiling Finish: painted; good condition.
- Ventilation: exhaust fan; fair condition; older unit.
- Interior Hardware: metal; fair condition; additional towel bar needed.

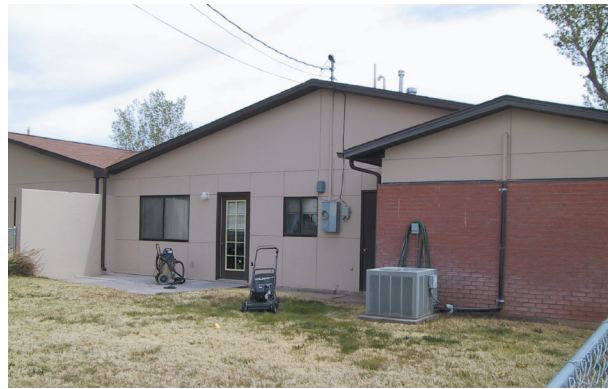
Rear elevation

- Exterior Wall Structure: wood frame; good condition.
- Exterior Wall Covering: stucco; good condition; brick veneer used as an accent, discolored from alkali in soil on 30% of unit.
- Foundation/Basement: slab on grade; good condition.
- Floor Structure: none; slab on grade.
- Windows - Frames: aluminum; good condition; minor corrosion of window finish from high alkali soil content.
- Windows - Glazing: double; good condition; bedroom windows provide emergency egress.
- Windows - Screens: aluminum; good condition.
- Doors - Entry: metal; good condition.
- Doors - Sliding Glass: metal; fair condition; corroded; no secondary locking device.
- Doors - Storm/Screen: aluminum; good condition.
- Doors - Hardware: brass; fair condition; no dead bolt on exterior doors.

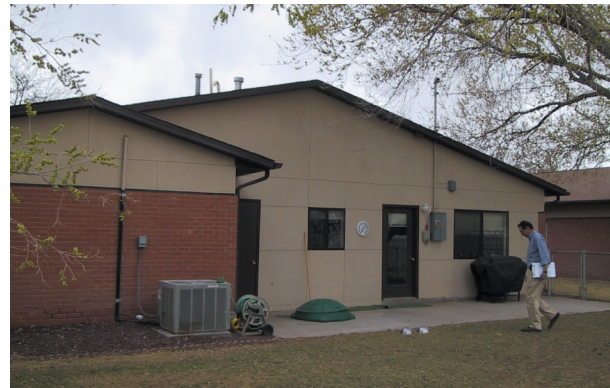
Rear elevation

- Exterior Wall Structure: wood frame; good condition.
- Exterior Wall Covering: brick veneer; fair condition; deteriorating 25% of mortar joints; stucco is in good condition.
- Foundation/Basement: slab on grade; good condition.
- Floor Structure: none; slab on grade.
- Windows - Frames: aluminum; good condition; minor corrosion of window finish from high alkali soil content.
- Windows - Glazing: double; good condition; bedroom windows provide emergency egress.
- Windows - Screens: aluminum; good condition.
- Doors - Entry: metal; good condition.
- Doors - Sliding Glass: aluminum; good condition; no secondary locking device.
- Doors - Storm/Screen: aluminum; good condition.
- Doors - Hardware: brass; fair condition; no dead bolt on exterior doors.

- Exterior Wall Covering: remove mortar, tuck point and clean brick in areas requiring maintenance.
- Windows - Frames: continue to monitor corrosion of frames; future window replacement may be required if corrosion continues.
- Doors - Sliding Glass: provide new secondary locking device.
- Doors - Hardware: install dead bolt on entry doors.

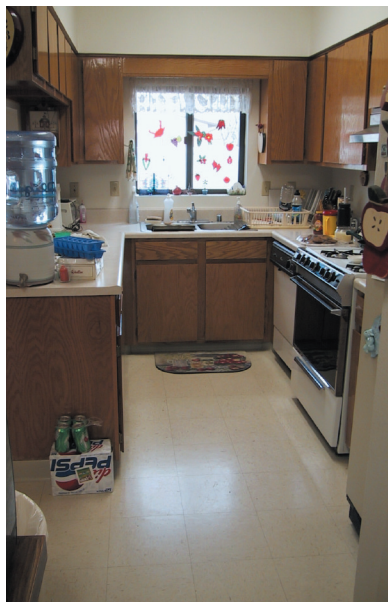
Kitchen

- Cabinets: wood; good condition.
- Counter Tops: laminated; good condition.
- Sink: stainless steel, double; good condition.
- Sink Fixtures: brass; good condition.
- Refrigerator: two door; good condition.
- Range/Oven: gas; good condition.
- Vent Hood: exhaust fan; good condition.
- Dishwasher: standard; good condition.
- Garbage Disposal: standard; good condition.
- Flooring: vinyl composition tile; good condition.
- Walls: gypsum wall board; good condition.
- Wall Finish: painted; good condition.
- Ceilings: gypsum wall board; good condition.
- Ceiling Finish: painted; good condition.
- Interior Hardware: none; not required.

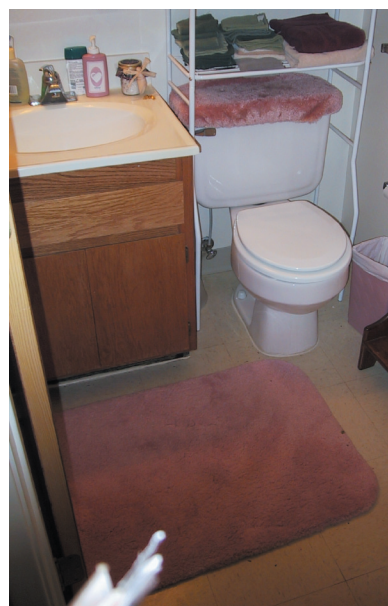
Bathroom 1

- Cabinets: wood; good condition.
- Counters: cultured marble; good condition.
- Sink: cultured marble; good condition.
- Fixture Hardware: metal; good condition.
- Toilet: porcelain; good condition.
- Tub/Shower: combination; good condition; ceramic tile surround.
- Flooring: vinyl composition tile; good condition.
- Walls: gypsum wall board; good condition.
- Wall Finish: painted; good condition.
- Ceilings: gypsum wall board; good condition.
- Ceiling Finish: painted; good condition.
- Ventilation: exhaust fan; good condition.
- Interior Hardware: brass; good condition.

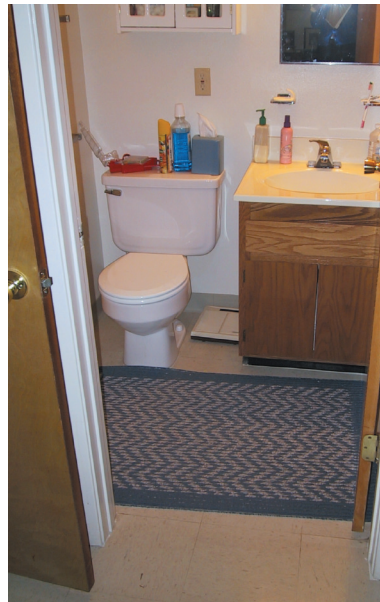
Bathroom 2

- Cabinets: wood; good condition.
- Counters: cultured marble; good condition.
- Sink: cultured marble; good condition.
- Fixture Hardware: metal; fair condition; end of useful life.
- Toilet: porcelain; good condition.
- Tub/Shower: shower; good condition.
- Flooring: vinyl composition tile; good condition.
- Walls: gypsum wall board; good condition.
- Wall Finish: painted; good condition.
- Ceilings: gypsum wall board; good condition.
- Ceiling Finish: painted; good condition.
- Ventilation: exhaust fan; good condition.
- Interior Hardware: metal; fair condition; worn finish.

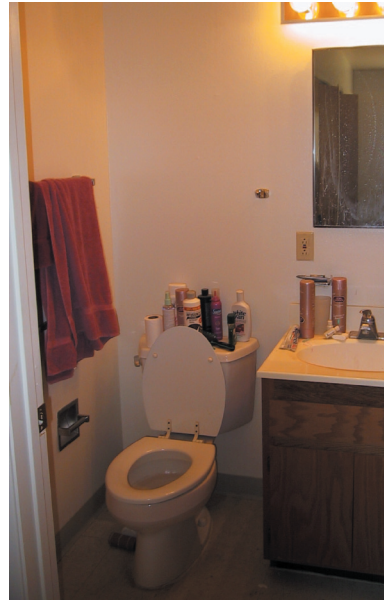
Bathroom 2

- Doors - Closet: bifold; fair condition; stain slightly worn.
- Window Treatment (Blinds): mini blinds; good condition.
- Closet Shelving: metal; fair condition; needs additional support brackets.
- Interior Hardware: metal; fair condition; worn finish.
- Arctic Recreation Room: none; not required at this location.

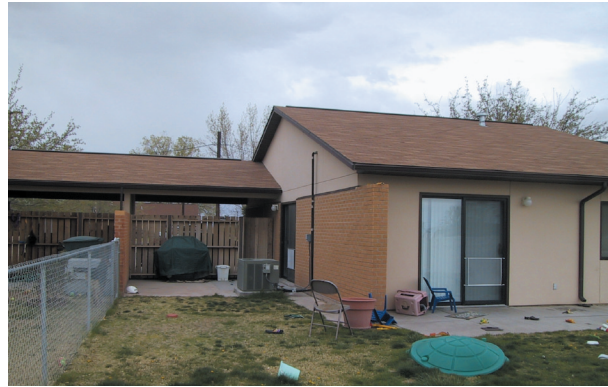
Right side elevation

- Exterior Wall Structure: wood frame; good condition.
- Exterior Wall Covering: stucco; good condition; brick veneer accent in good condition.
- Foundation/Basement: slab on grade; good condition.
- Floor Structure: none; slab on grade.
- Windows - Frames: aluminum; good condition; minor corrosion of window finish from high alkali soil content.
- Windows - Glazing: double; good condition; bedroom windows provide emergency egress.
- Windows - Screens: aluminum; good condition.
- Doors - Entry: metal; good condition.
- Doors - Sliding Glass: aluminum; fair condition; at family and dining rooms; no secondary locking devices.
- Doors - Storm/Screen: none; required; screen door at laundry/storage; poor condition.
- Doors - Hardware: brass; fair condition; no dead bolt on exterior doors.
